HEAT SHIELD CHARACTERIZATION

Outer Planet Atmospheric Entry Probe

By S. A. Mezines, E. L. Rusert and E. F. Disser

MCDONNELL DOUGLAS ASTRONAUTICS COMPANY - EAST

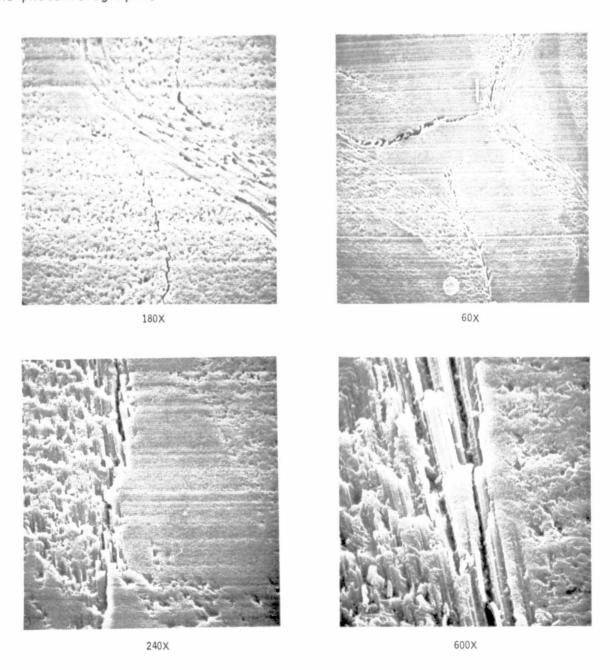
FIGURE 32
PHOTOMICROGRAPH OF NOSE CAP PLUG CORE

The two plugs cored from the heat shield were examined under high mangification with a Scanning Electronic Microscope (SEM). Photomicrographs of the two core specimen confirmed the presence of cracks that were previously observed visually. Figure 32 shows the crack microstructure for the nose cap plug

The delaminations identified by visual and microscopic means were all between adjacent plies rather than across plies which would have occurred if the carbon reinforcement was sheared. This is very important since the former type presents a much lower risk for the flight heat shield than the latter.

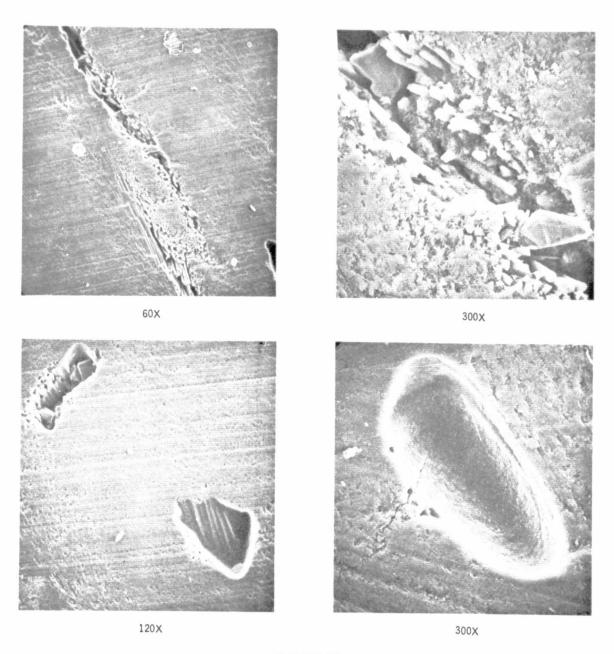
FIGURE 33
PHOTOMICROGRAPH OF BASE CORNER PLUG CORE

magnified 60 to 300 times. Similarly, the photomicrographs of the base corner plug shown in Figure 33 illustrate the lower quality of the heat shield in that area. In examining the photomicrographs, one should bear in mind the high magnification involved and that a machining operation (coring) was performed which may have contributed or even caused the rough surface condition shown in the photomicrographs.

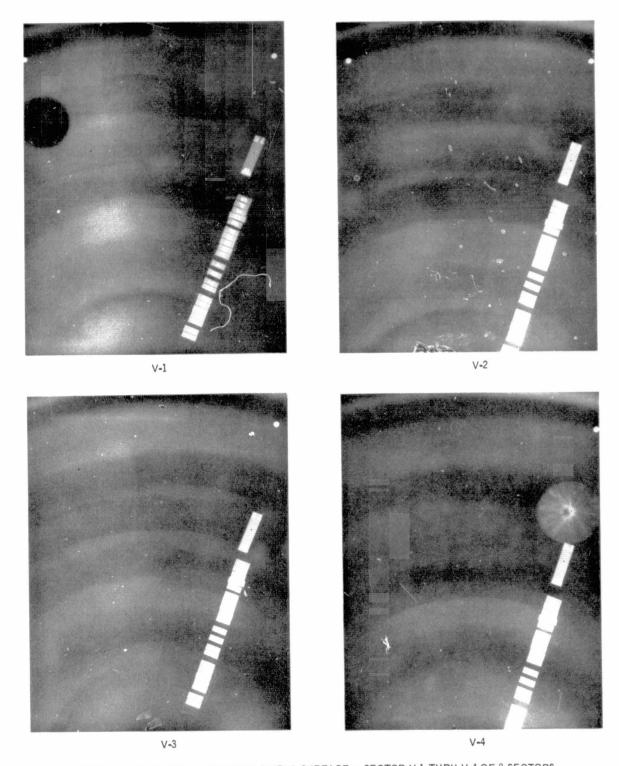
FIGURE 34A X-RAY PHOTOGRAPHS OF SECTOR V-8B

X-rays - X-ray photography is a standard nondestructive test method used to detect cracks and/or internal voids. The x-ray parameters and the different sector layouts are presented in Figure 34. X-ray photographs of the heat shield were taken in two directions: (1) normal to the surface (30° inclination to the plies) for the entire heat shield and (2) parallel to the plies (base corner edge and one sector of the main body to demonstrate the differences from the normal direction). Ply delaminations (cracks) were detected and they appeared as dark lines in the x-rays (see Figure 34A for typical example) when viewed in the parallel direction and as dark zones (Figures 34B and 34C, i.e., the projection of 30° unbonded plies) when viewed normal to the surface. The base corner was also x-rayed parallel to the plies and only sector U-3A revealed two low density areas both approximately 0.148 cm x 1.38 cm. All other edge views were acceptable. It was determined that cracks or delaminations between carbon phenolic plies can be detected and that the x-rays be taken parallel to the ply surfaces. X-rays are useful for this heat shield configuration and thickness (approximate 2.9 cm) for detecting both porous areas and delaminations or cracks.

NOTES: 1. X-RAY PARALLEL TO THE PLY ORIENTATION
2. DELAMINATIONS APPEAR AS DARK LINES.
